CONTAMINATED LAND ASSESSMENT
FOR A
REZONING AND MULTI-USE SUBDIVISION AT
LOT 1 DP 772605, LOT 1 DP772604, AND
LOTS 471 TO 474 DP 755718
CRAWFORD ROAD, EAST LISMORE

A preliminary assessment of possible soil contamination as required for
State Environmental Planning Policy 55

REPORT NO.: A2329

DATE: 12 June 2009

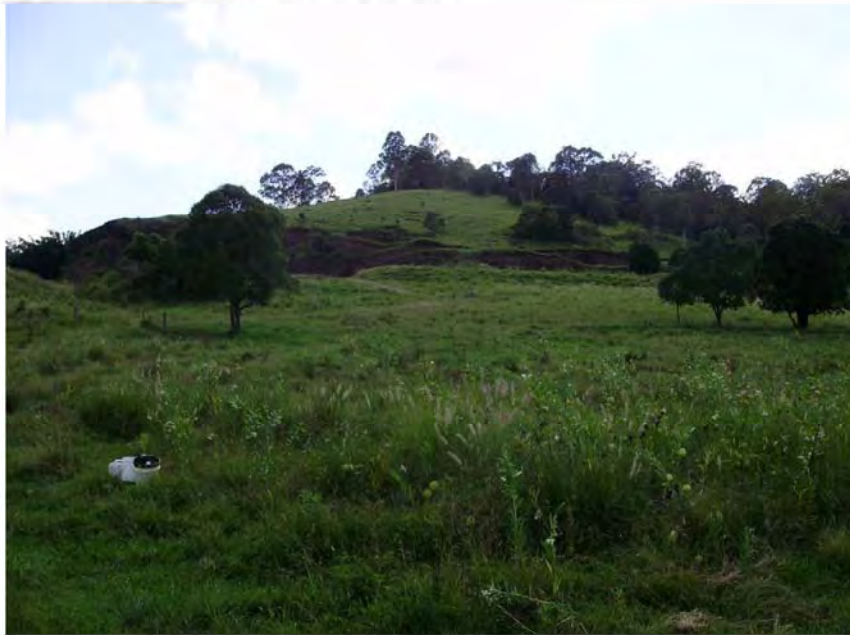
Plate 1: Northerly view of quarry face.

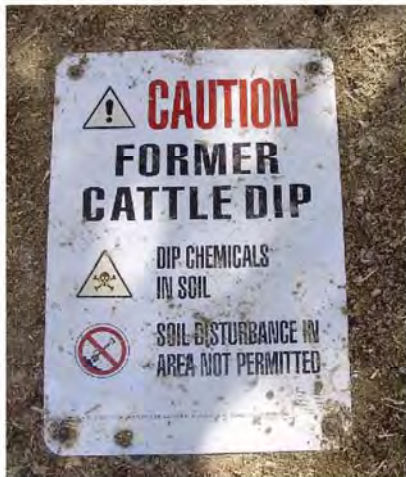
Plate 2 (above): Signage on Dip Site

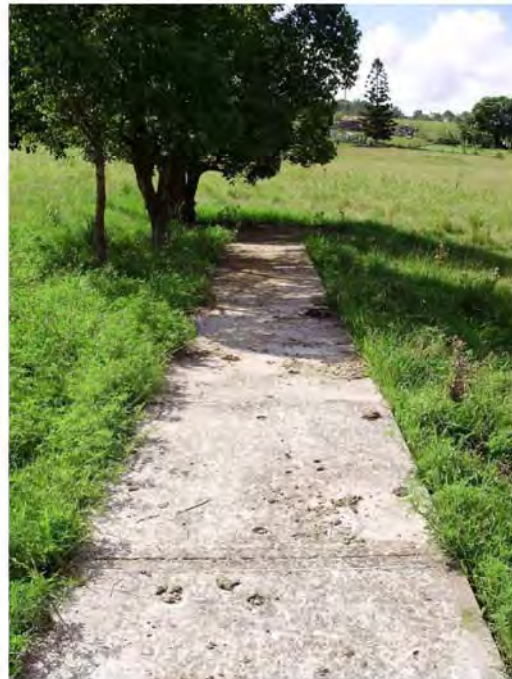
Plate 3 (right): Remnants of Maize Grove Dip Site

Analysis of samples taken in the vicinity of the decommissioned Maize Grove dip site showed no elevated levels of metals or pesticides for the majority of the investigated area. The exceptions were all samples showed elevated levels of Manganese to varying intensity (refer Table 10) which can be attributed to natural background levels. Elevated Arsenic levels were found in Composite samples DC6 and DC7. Further reanalysis of these samples (i.e. DT1 and TP 1 to 5) showed that while Arsenic levels were elevated they did not breach the acceptable DEC (2006) Column 4, Commercial/Industrial limit. However, as a precautionary measure it is advised the area is excluded for development if a subsequent development proposal allows. The topography of the area is relatively flat and as Arsenic typically binds strongly to soil. The spread of contamination is considered limited to the area assessed and the remaining area within the 200m buffer zone would be suitable to further development. The dip site area should be fenced off, clearly marked and access excluded. If a specific industrial land use is proposed for the area, it is advised further assessment is undertaken to determine the allowable activity and extent of the footprint or the ultimate requirement for any remedial activities. For example, the area may be well suited to the placement of an industrial shed which would effectively cap the contamination. The sizing and shape of such a shed and access would need to ensure the contaminated area is contained beneath the development footprint and the remaining area would need to be validated.

Analysis of samples taken in the vicinity of the decommissioned Maize Grove dip site in general showed no elevated levels of metals or pesticides for the majority of the investigated area. The exception was elevated Arsenic levels found in Composite samples DC6 and DC7. Further reanalysis of these samples (i.e. DT1 and TP 1 to 5) showed that while Arsenic levels were elevated (above expected background values) however they did not breach the acceptable Column 4 HBIL. However, it is recommended as a precautionary measure, the area is excluded for development if a subsequent development proposal allows. The dip site area should be fencing off and access excluded. If a specific industrial land use is proposed for the area, it is advised further assessment is undertaken to determine the allowable activity and extent of the footprint. For example, the area may be well suited to the placement of an industrial shed which would effectively cap the contamination. The sizing and shape of such a shed and access would need to ensure the contaminated area is contained beneath the development footprint and the remaining area would need to be validated.

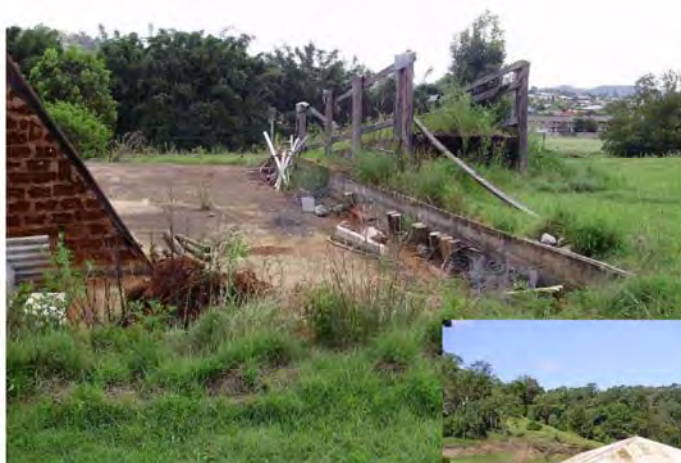
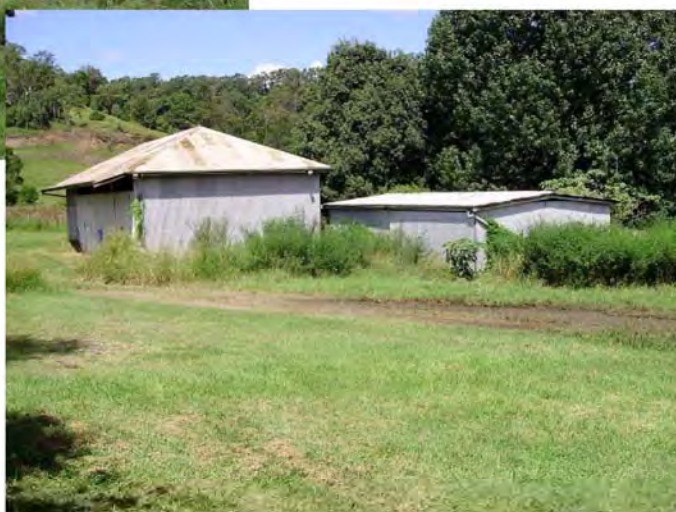
**Plate 5 (left) and Plate 6 (below):
General views of condition of
farm sheds located on the site.**

Concentrations of TPH were recorded at levels that breached the adopted guideline values for Service Station sites (EPA 1994) in two samples taken in close proximity to sheds (Refer Table 8). If samples had been reanalysed for distribution of aromatics and aliphatics it is likely the analysis would confirm the dominance of aliphatics present as the portion of aliphatics is much greater and aromatics tend to volatilise with time and be more readily biodegradable and water soluble. Thus, the Column 1 Residential limit of 56,000 mg/kg (DEC 2006) are considered appropriate and thereby the levels found do not breach this limit. Further, the TPH contamination found would most likely be attributed to activities such as oil leaks from tractors/farm machinery while parked and/or during maintenance works and would be expected be confined to very small areas. That is, it is unlikely the contamination would be distributed across a wide surface area or be dispersed vertically through the soil profile.

Similarly, targeted sampling around building on the site did not generally result in acceptable limits being breached. Levels of TPH near tow (2) farm sheds just breached the acceptable limit for Service Station sites. It is concluded that these levels are inconsequential as if further analysis is undertaken the TPH found is likely to be from the aliphatic fraction and the Column 1 HBIL may be utilised of which the levels found do not breach.

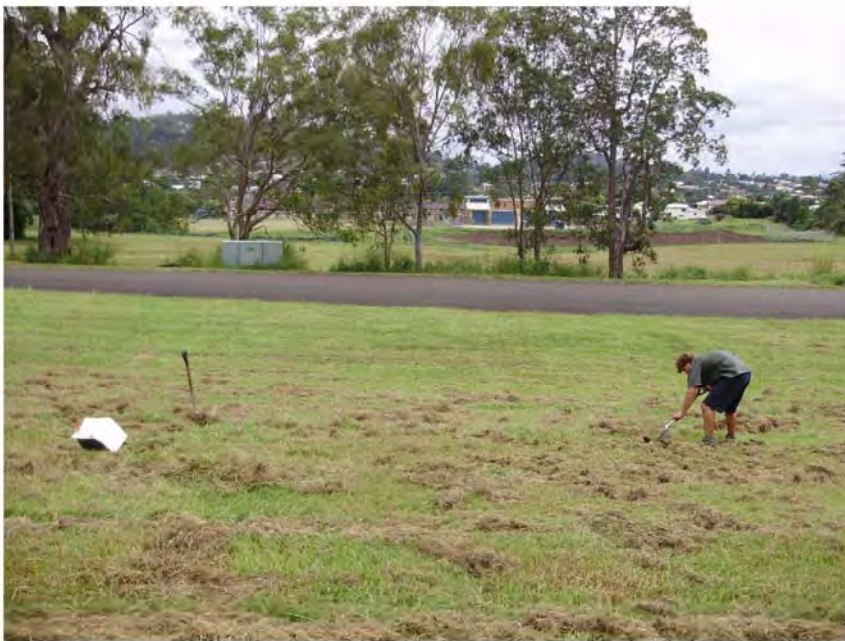
Plate 8: Westerly view of Sampling Point 74 (marked with shovel in left of frame).

Concentrations for Lead and Mercury recorded for Composite Sample 20 were found to be above the adopted acceptable limit (Column 1, Residential) with levels of Zinc also found to be elevated above background levels (Refer Table 5). Further analysis of the individual samples identified soils collected from individual sample point SP74 had concentrations of Lead, Cadmium, Manganese and Zinc above the adopted Residential guideline values and Copper and Mercury were found at levels elevated above expected background values. Additional sampling was undertaken around SP74 to determine the lateral extent of the contamination (Refer Fig. 4; Appendix 1). All metal concentrations in the additional samples analysed were well below the DEC (2006) Residential guidelines with the exception of Manganese. The level of Manganese can be attributed to natural background levels in the volcanic basalt derived soils in this region (Lancaster 2006). Elevated levels of Lead and Zinc and higher levels of Copper and Mercury in the original sample (SP74) could not be attributed to any obvious contamination source as no buildings or remnants were located in the area (refer Plate 8, Appendix 2). Lead and Zinc is often associated with paint, while Copper and Mercury are associated with fungicides for horticultural land uses. It is therefore possible the contamination has resulted from the disposal of paint and fungicides in the area but no anecdotal evidence is available to confirm this assumption. Further, the result could be considered an anomaly. At the least, the contamination is restricted to a very small area as the sample taken as close as possible to the original location (74E) did not record elevated Lead or Zinc levels nor did other samples taken within a 10m circumference of the original sample (i.e. SP74).
