### **Results of Noise Monitoring**

**Blakebrook Quarry  
186A Keerrong Road  
Blakebrook NSW 2480**

**Northern Rivers Quarry & Asphalt  
186A Keerrong Road  
Blakebrook NSW 2480**

Prepared by  
Garry Hall  
November 14<sup>th</sup> 2017

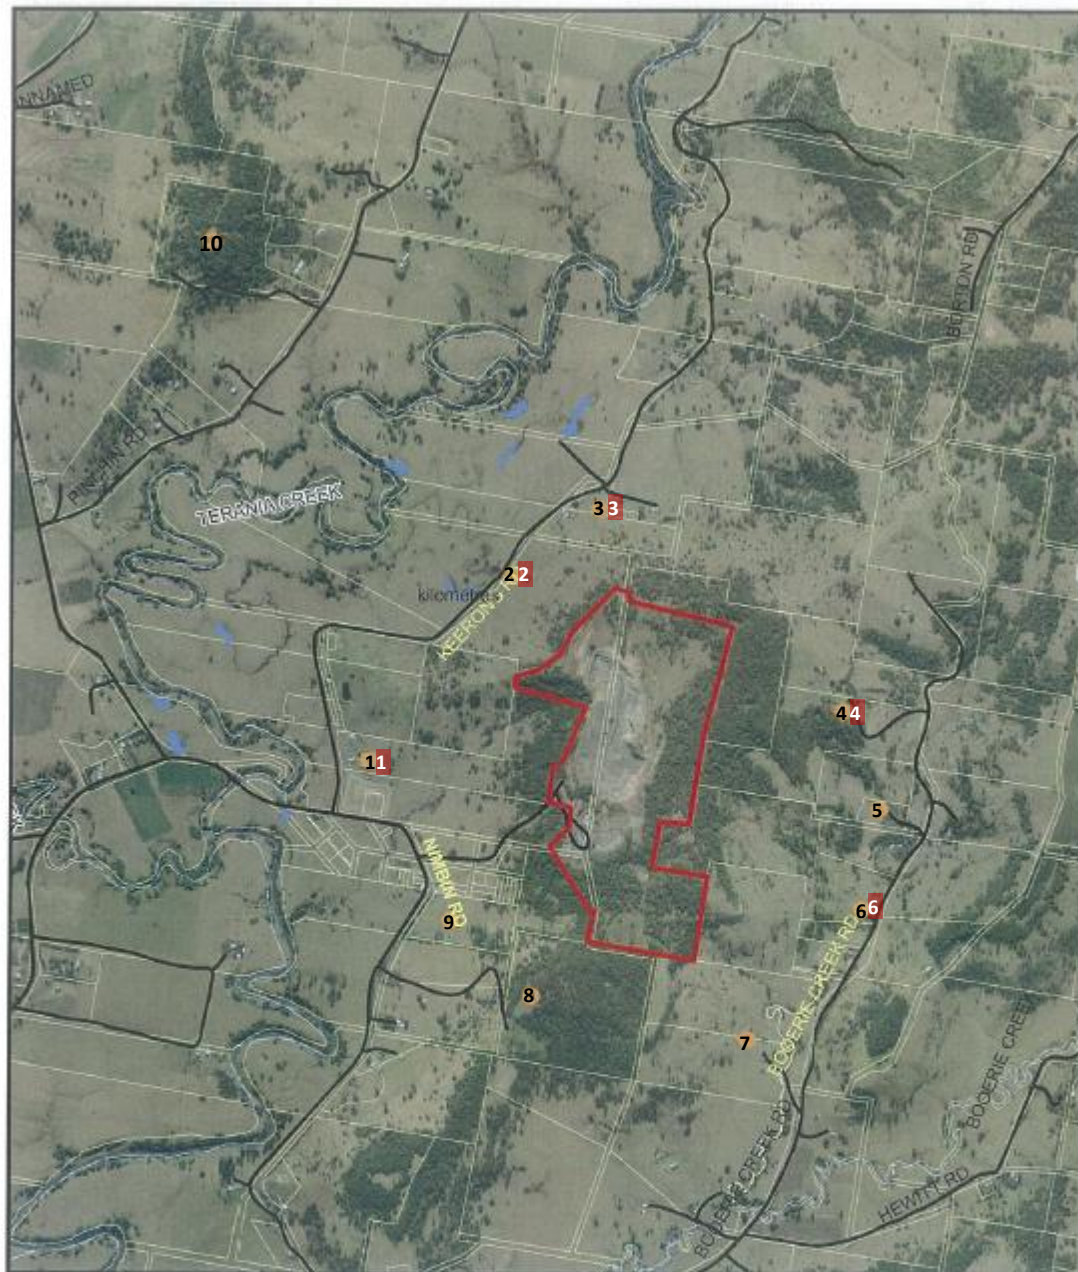
Figure 2.1 Noise Monitoring Locations

The closest noise sensitive receivers and required noise monitoring locations are indicated in figure 6.1 from the ERM Noise, Vibration and Blasting Sub Plan, which is copied on the following page.

Noise monitoring at locations 1,2,3 and 4 were conducted within 30m of the residential dwelling in the direction of the quarry. Location 6 was conducted at the road frontage.

**Figure 6.1**  
**Noise and Vibration**  
**Sensitive Receptor Locations**

Noise, vibration and blasting monitoring will be undertaken at the nearest residential receptors marked as locations 1 to 6 on *Figure 6.1*.

Operator - attended noise measurements shall be conducted at Locations 1 to 4, Location 6 and Location 9 (refer *Figure 6.1*) to quantify and characterise the maximum (LA<sub>max</sub>), the energy equivalent (LA<sub>eq</sub>), and background (LA<sub>90</sub>) noise levels from ambient noise sources and quarrying operations over a 15 minute measurement period.

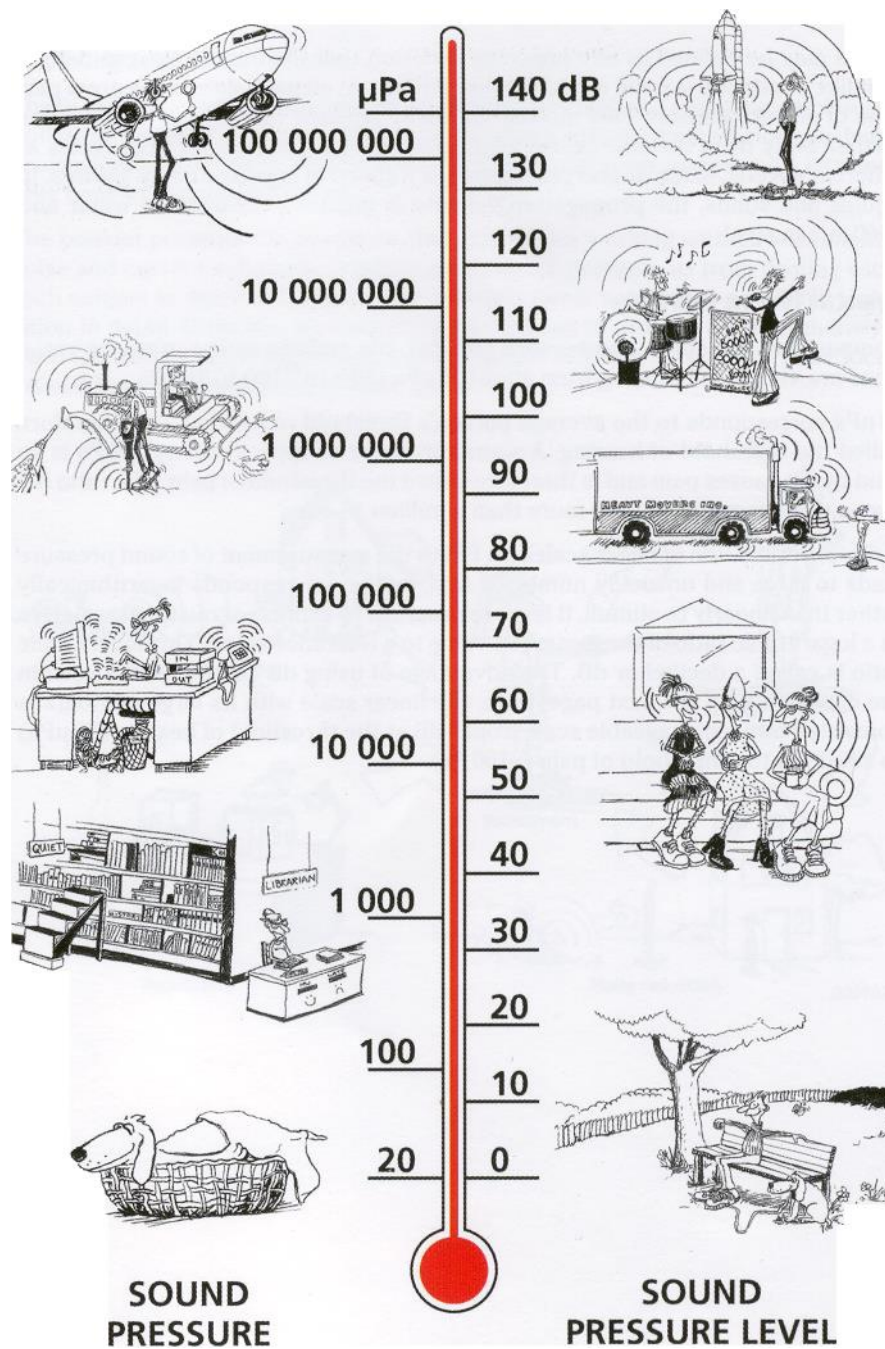
## APPENDIX B Comparison of Sound Pressure Levels

Our hearing covers a wide range of sound pressures – a ratio of over a million to one. The dB scale makes the numbers manageable.

One useful aspect of the decibel scale is that it gives a much better approximation to the human perception of relative loudness than the Pascal scale. This is because the ear reacts to a logarithmic change in level, which corresponds to the decibel scale where 1 dB is the same relative change every on the scale. *Refer Appendix B*

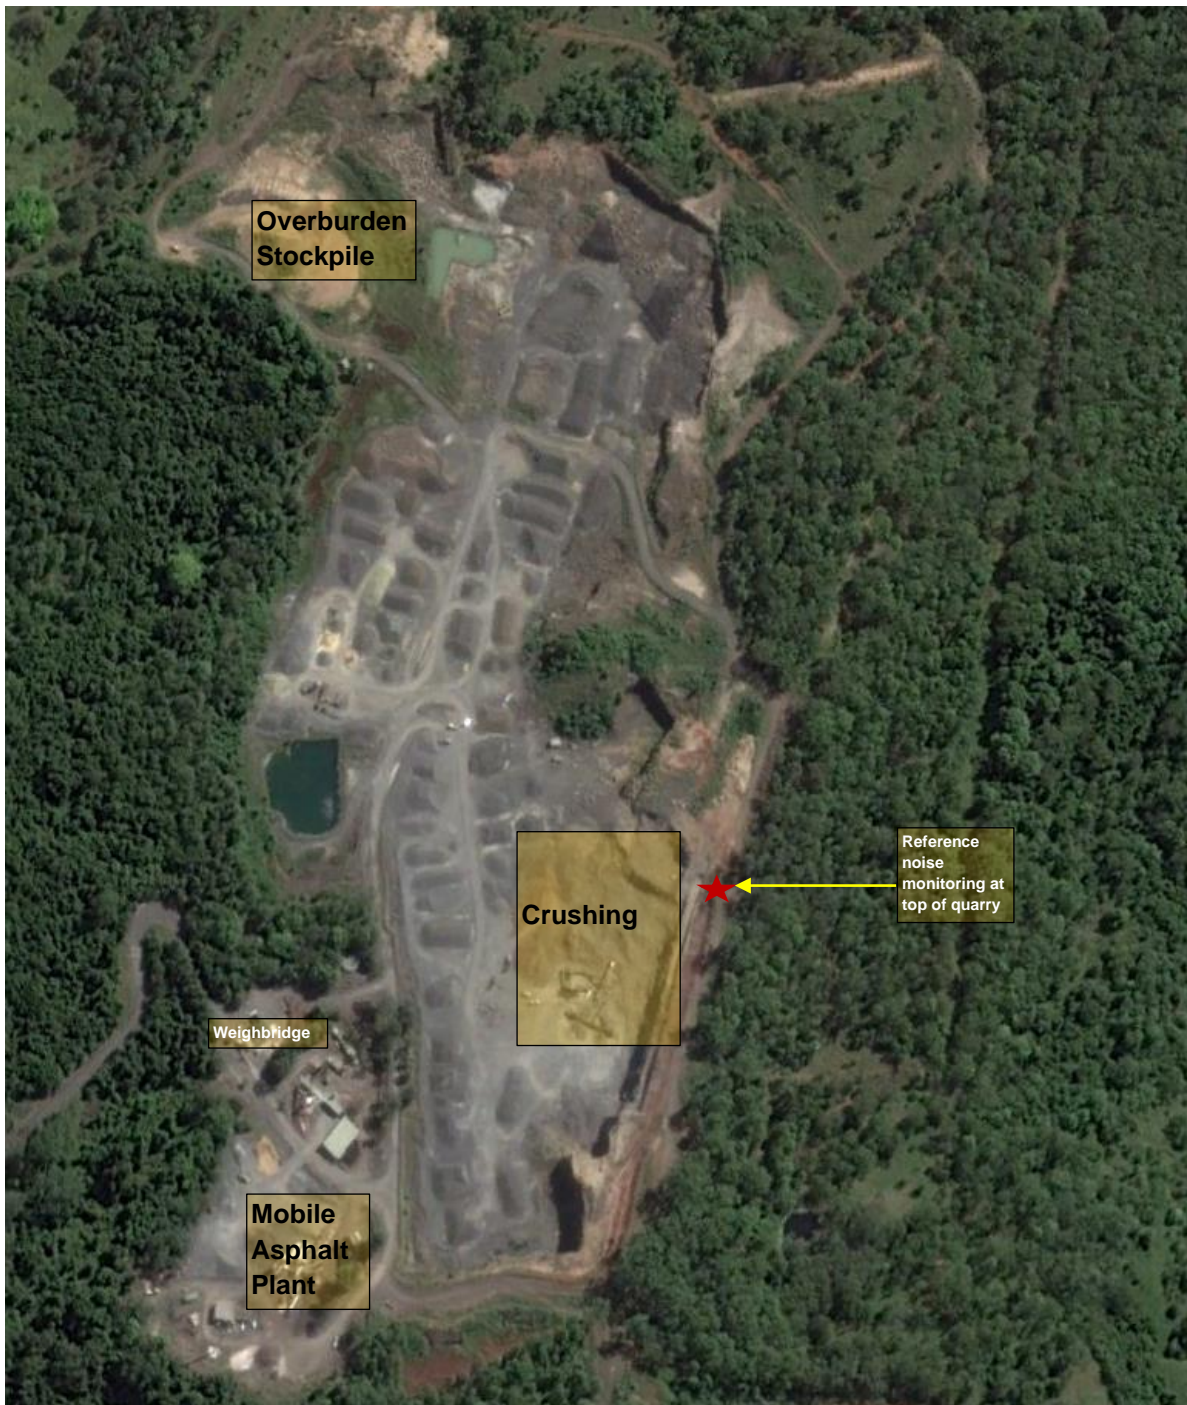
**Appendix D**  
**Quarry Operations 7<sup>th</sup> and 9<sup>th</sup> November 2017**

Note : Aerial photo not of operations on 7th and 9th of November 2017

Quarry operations while noise monitoring was conducted included crushing and stockpiling on the eastern side of the quarry floor, asphalt production at the mobile plant at the top of the quarry and trucks and loaders on the internal haul roads. A diagram of equipment operating on the quarry floor during noise monitoring at residential receivers is provided in Appendix D

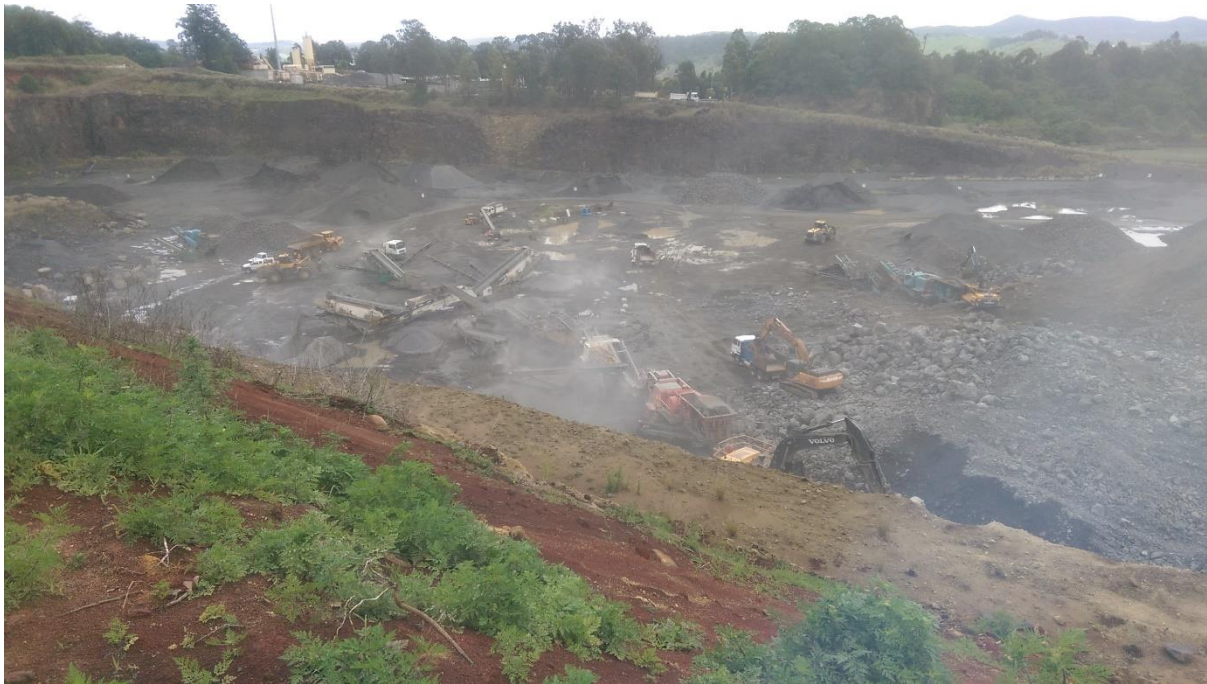
## Crushing Operations 07, 09 November 2017

2 jaw crushers

4 screen decks

1 cone crusher

1 VSI crusher

4 excavators

2 dump trucks

2 front end loaders

various haul trucks
