Results of Noise Monitoring

**Blakebrook Quarry
186A Keerrong Road
Blakebrook NSW 2480**

**Northern Rivers Quarry & Asphalt
186A Keerrong Road
Blakebrook NSW 2480**

Prepared by
Garry Hall
November 12th 2018

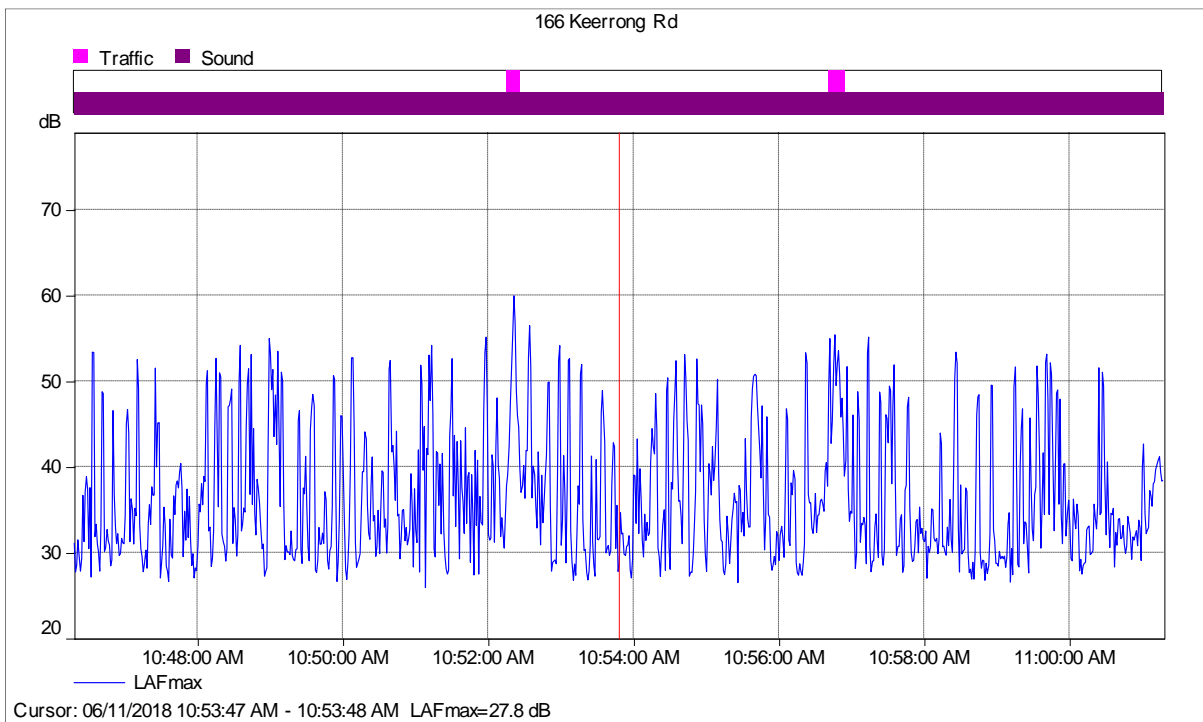
Graph C.2 Receiver 2

At Receiver 2, the quarry noise was not audible. The $L_{A90,15\text{min}}$ is quite low (26.3 dB(A)). It is estimated that the quarry $L_{Aeq,15\text{ min}}$ is below 30dB(A).

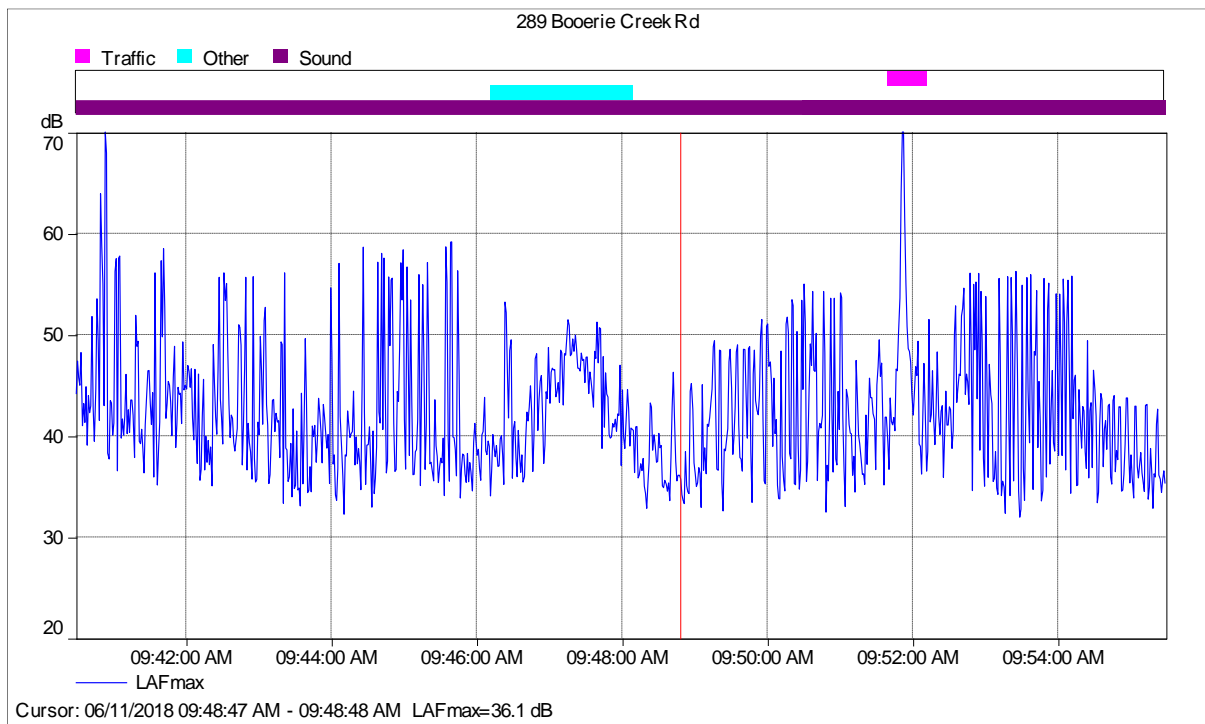
Graph C.5 Receiver 6

At Receiver 6, the quarry noise was not audible. The $L_{A90,15\text{min}}$ was 32.5 dB(A). It is estimated that the quarry $L_{Aeq,15\text{ min}}$ is below 33dB(A).

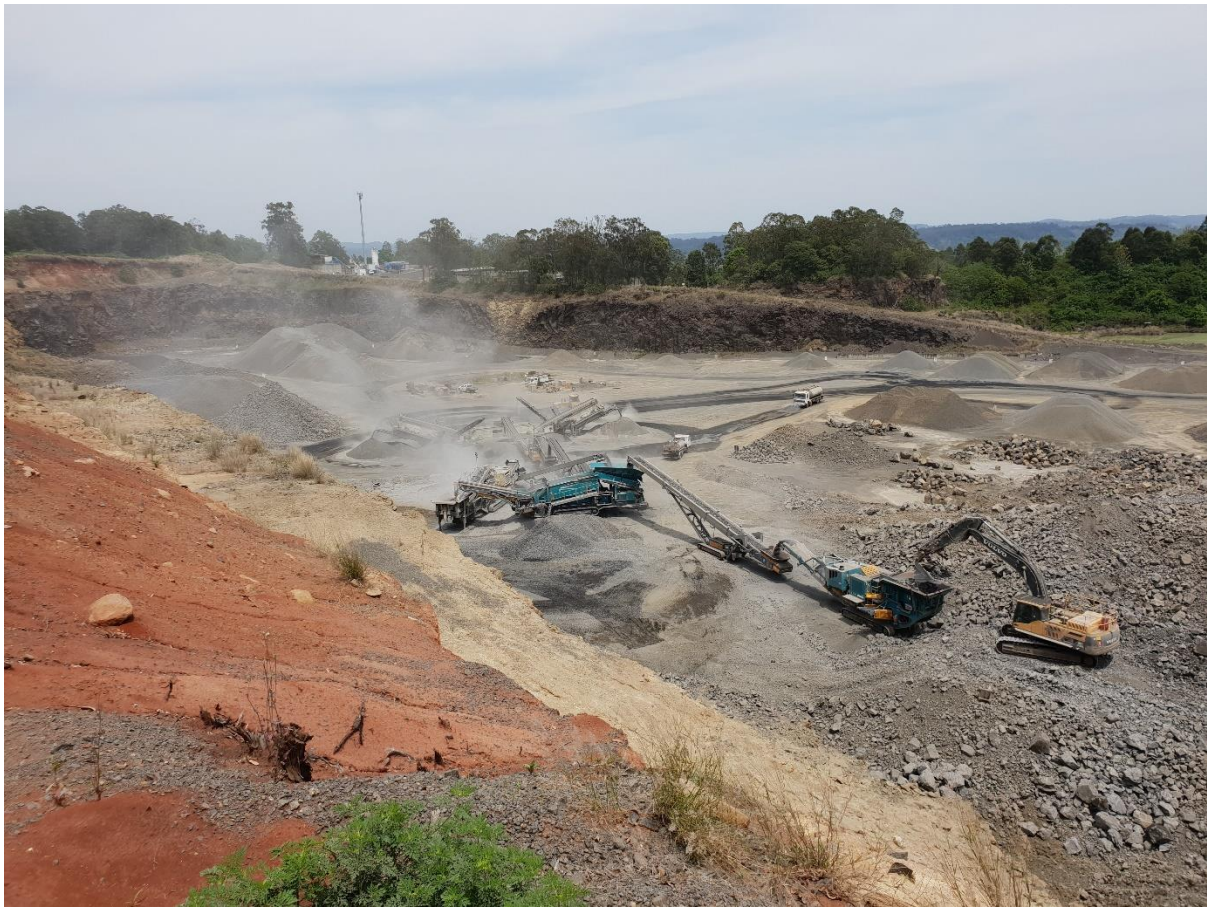
Crushing Operations 6th November 2018

Quarry operations while noise monitoring was conducted included crushing and stockpiling on the eastern side of the quarry floor, asphalt production at the mobile plant at the top of the quarry and trucks and loaders on the internal haul roads. A diagram of equipment operating on the quarry floor during noise monitoring at residential receivers is provided in Appendix D.

1 jaw crusher

2 screen decks

1 cone crusher

1 VSI crusher

1 excavator

1 tracked stockpiler

1 scalper reclaimer

2 front end loaders

1 water truck
