Results of Noise Monitoring

Blakebrook Quarry
550 Nimbin Road
Blakebrook NSW 2480

Ecoteam
13 Ewing Street
Lismore NSW 2480

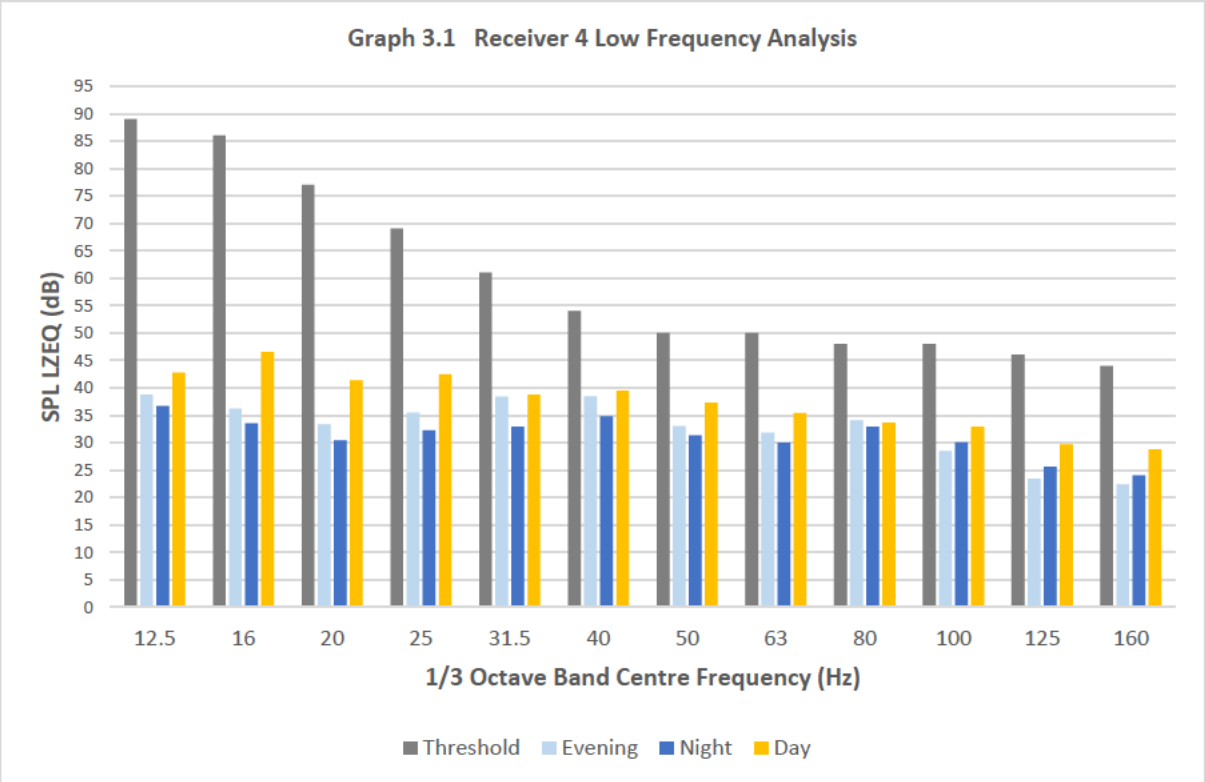
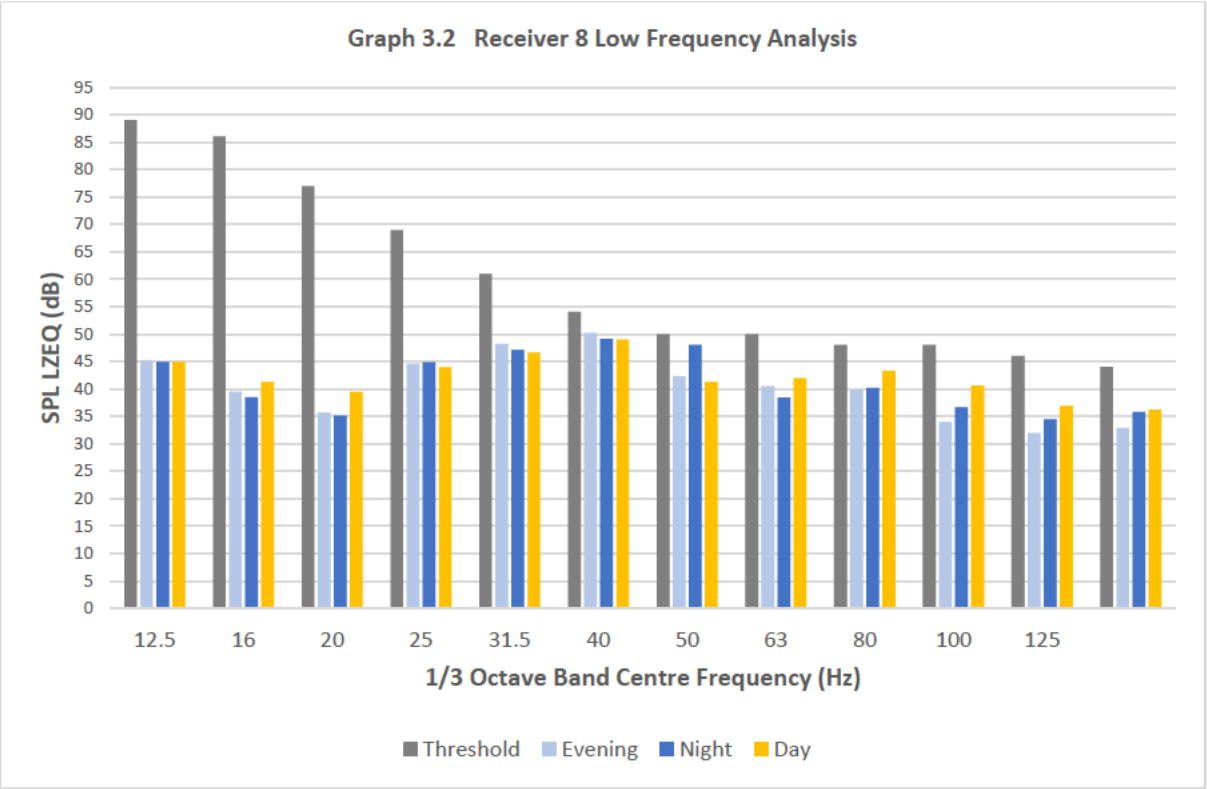
The difference between the A and C L_{eq} levels at Receivers 4 and 8 was greater than 15 decibels during some measurements.

Low frequency noise from asphalt plant operations was barely audible or just audible at Receiver 4 for the day, evening and night time periods. The low frequency analysis indicates the measured low frequency is below the low frequency criteria. It is estimated quarry operations at Receiver 4 are below 32 dB(A) $L_{eq,15min}$ for calm meteorological conditions.

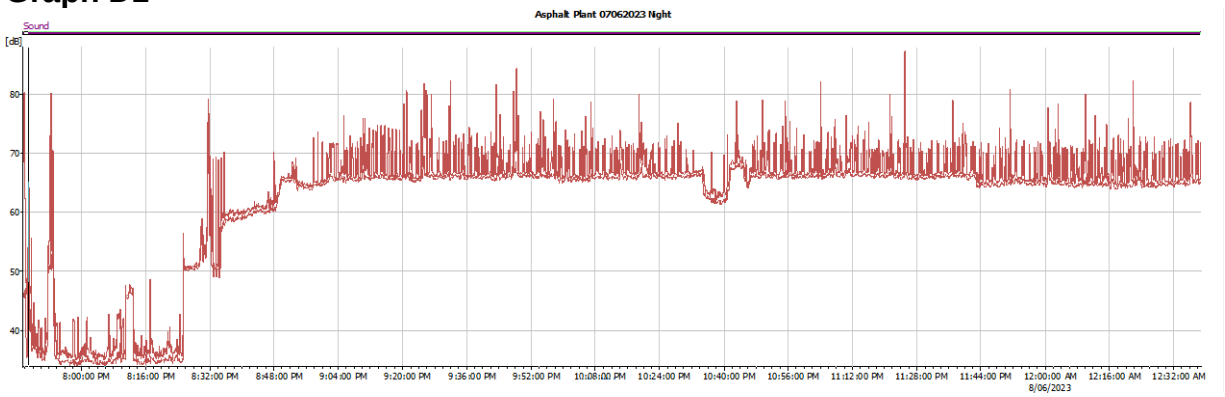
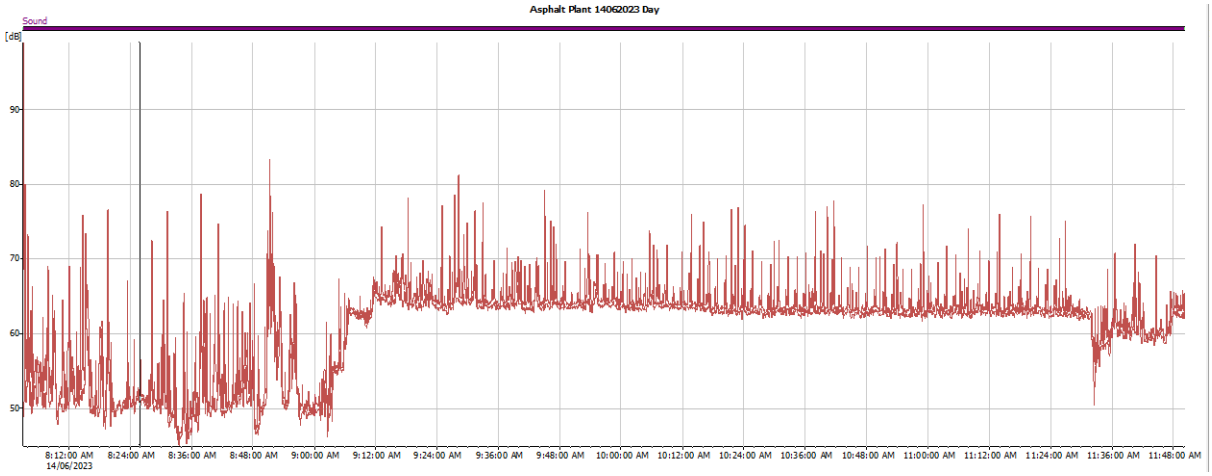
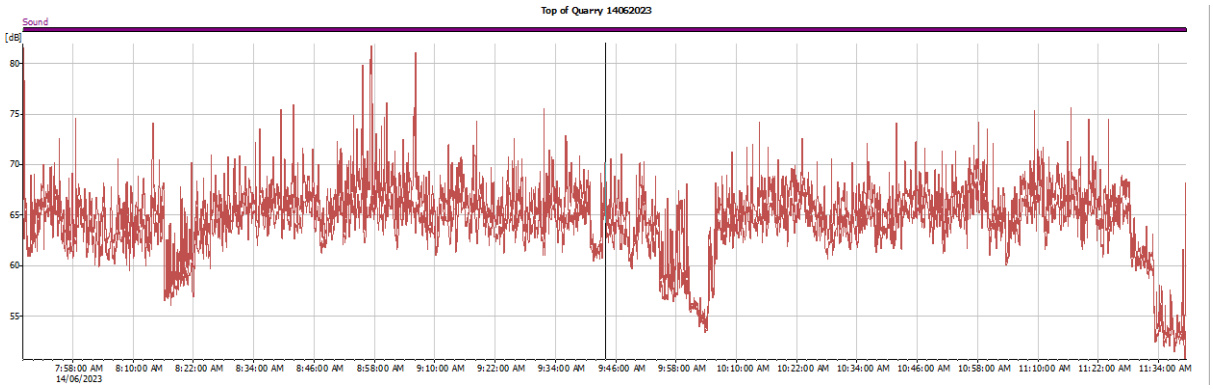
The noise loggers above the quarry and near the asphalt plant indicated that there was consistent quarry and asphalt plant noise during the measurement periods at receiver locations (graphs D1, D2, D3).

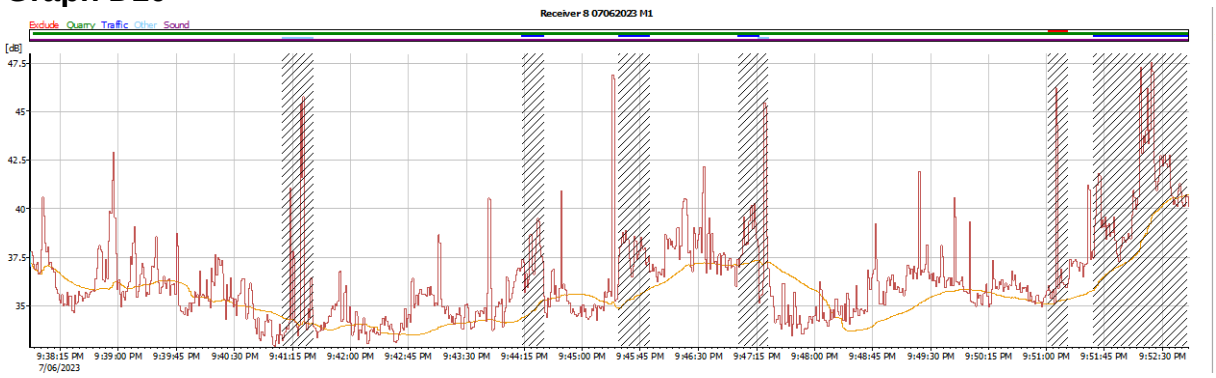
The noise levels at the asphalt plant are very consistent 65 – 66 L_{AFmax} during the evening and night time measurement periods. Graph D10 indicates the noise level from 34 dB(A) to 38 dB(A) when no other noise sources are present. The increase is due to the downwind location of Receiver 8 during breezes from the north. The wind was calm at the noise monitoring location as it was in a sheltered location. The strength of the breeze was not strong enough to cause noticeable foliage noise at the Receiver 8 measurement location.
